Reflective Cracking Construction Notes

Date: January 21, 2015

Project: Reflective Cracking Indoor Phase IV

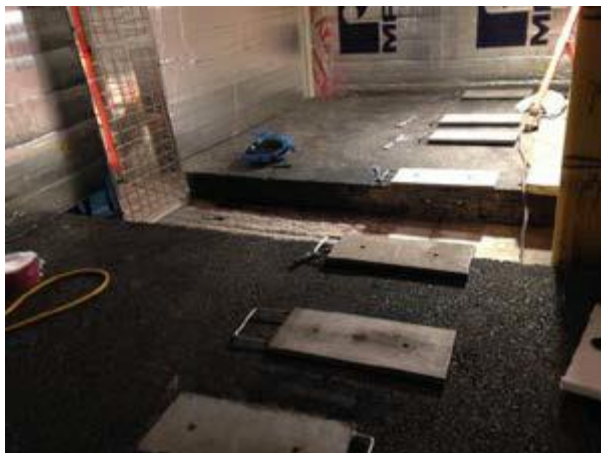
(a)

After receiving email direction from the Gemini engineer to install the majority of the surface strain gauges on the Phase IV asphalt test items, an SRA engineer applied the adhesive to the top surface of the asphalt test items within the environmental chamber and affixed (8) of the required (18) surface gauges ((3) of the side surface gauges on the South test item were eliminated as a result of cracks initiated by the rig movement incident). The gauges were weighed down with steel plates to stabilize the gauges and ensure good contact with the test surface as the adhesive cures, as shown in Figure 1.

Figure 1. Surface Strain Gauges Weighed Down with Steel Plates.
